**DEPARTMENT OF TRANSPORTATION**

Contract #: 04-0120F4Cty: SF/ALA Rte: 80 PM: 13.2/13.9File #: 69.28**WELDING INSPECTION REPORT****Resident Engineer:** Pursell, Gary**Address:** 333 Burma Road**City:** Oakland, CA 94607**Report No:** WIR-003172**Date Inspected:** 18-Jun-2008**Project Name:** SAS Superstructure**OSM Arrival Time:****Prime Contractor:** American Bridge/Fluor Enterprises, a JV**OSM Departure Time:****Contractor:** Zhenhua Port Machinery Company, Ltd (ZPMC), Changxing Island **Location:** Shanghai, China**CWI Name:** Sun Wei**CWI Present:** Yes No**Inspected CWI report:** Yes No N/A**Rod Oven in Use:** Yes No N/A**Electrode to specification:** Yes No N/A**Weld Procedures Followed:** Yes No N/A**Qualified Welders:** Yes No N/A**Verified Joint Fit-up:** Yes No N/A**Approved Drawings:** Yes No N/A**Approved WPS:** Yes No N/A**Delayed / Cancelled:** Yes No N/A**Bridge No:** 34-0006**Component:** OBG and Tower**Summary of Items Observed:**

## WELDING INSPECTION REPORT

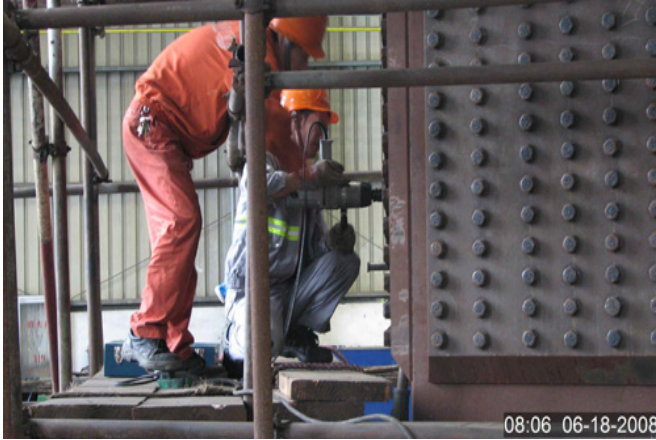
The Quality Assurance Inspector observed ZPMC using an electric impact wrench to tension high strength bolts at the exterior bolted connection plate. Below is a digital photograph illustrating the work in progress.
